**UNITED STATES AIR FORCE**  
**AIRCRAFT ACCIDENT INVESTIGATION**  
**BOARD REPORT**

**E-11A, T/N 11-9358**

**LOCATION: GHAZNI PROVINCE, AFGHANISTAN**

**DATE OF ACCIDENT: 27 JANUARY 2020**

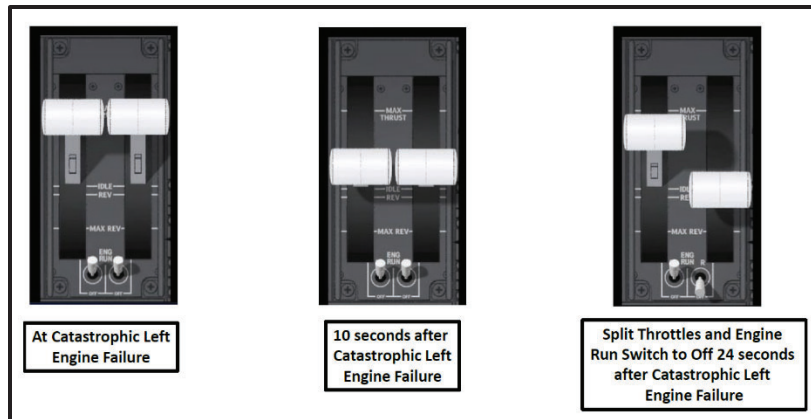
**Tab Z-12 (Simulated)**

Ten seconds after the catastrophic left engine failure, the MC retarded both throttles to just less than halfway (14 degrees; total throttle range is from 0 – 40 degrees) for one second, then slightly advancing the left throttle separately (26 degrees) for one second, then retarding it to align with the right throttle (both at 16 degrees) for one second, and finally splitting the throttles to advance the left throttle (to 31 degrees) while retarding the right to idle (0 degrees) (Tab DD-13 to DD-14). Nine seconds after moving the right throttle to idle, the MC placed the right engine run switch to off, shutting down the right engine (Tab DD-15). Finally, at 1251:19L, the left throttle was advanced to full power (40 degrees), briefly cycled then brought to idle (Tab DD-15). At 1251:23L, both throttles were advanced from idle to full power (Tab DD-15).

The first throttle movements may represent an attempt to first reduce vibration by reducing power, then to isolate the affected engine by moving the left throttle separately. Airframe vibrations did dampen slightly, but then resumed, roughly coincident with the power reduction and the advancement of the left throttle at 1251:08 (Tab DD-12 to DD-13). However, the moves were very brief and the vibrations in the left and right and up and down directions were cyclical but not regular (Tab DD-13). In any case, the left engine did not respond – the engine N1 ( fan RPM) had spiked to a maximum value, but other engine instruments continued to roll back consistent with an engine shutdown (Tab DD-13).

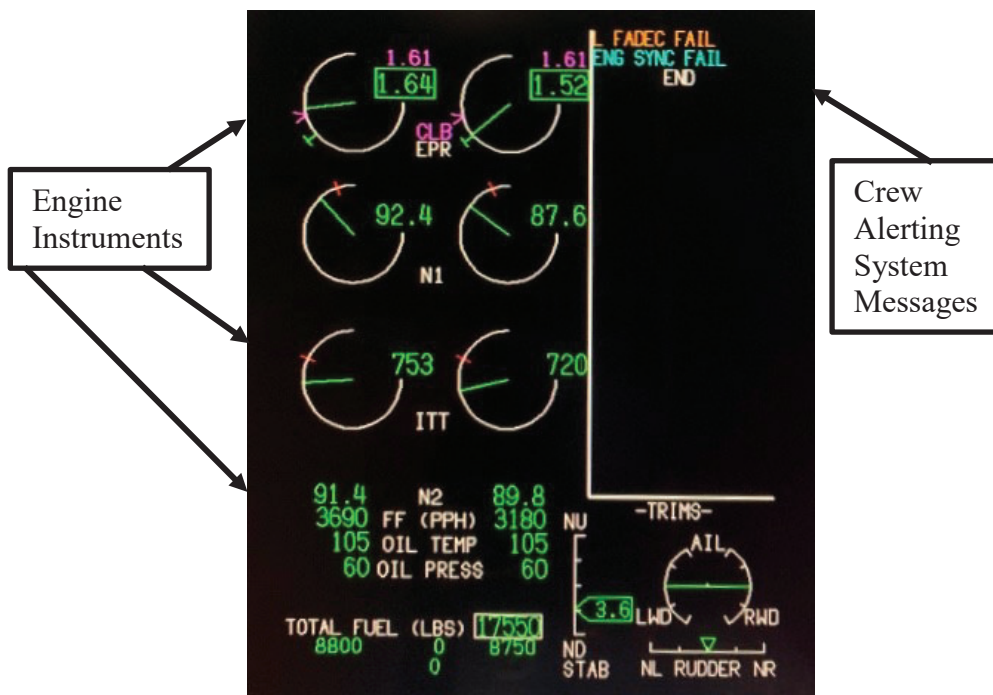
Tab Z-13 (Simulated)

The design of the MA's crew alerting system display and supporting inputs displayed an amber "**L (Left) FADEC FAIL**" caution crew alerting system message, accompanied by the amber Master Caution light at MC eye level (on the cockpit glareshield), derived from the software-directed shutdown of the left engine at 1250:52L (Tab J-179). A large majority of squadron E-11A pilots interviewed understood this message to indicate a failure of the software, but not necessarily to affect the engine in the short term (Tabs V-2.4 to V-2.6, V-3.4, V-7.4 to V-7.5, V-11.5 and V-22.3 to V-22.5). The checklist for "**L FADEC FAIL**" lists three possible consequences of the failure, one of which is eventual engine shutdown (Tab AA-20). The disengagement of the auto-throttles would have caused an audible warning, though the throttles would be expected to, and did, remain in place (Tab J-116 and J-136). Finally, a cyan "**ENG (Engine) SYNC FAIL**" advisory crew alerting system message was displayed (Tab J-179). Collectively, in the first moments, the crew alerting system did not directly indicate the left engine failure (Tab Z-13).

**EICAS Display #1:** A representative image of the crew alerting system messages within 1-2 seconds of the initial event and the left engine's FADEC-directed shutdown (Tab DD-6)

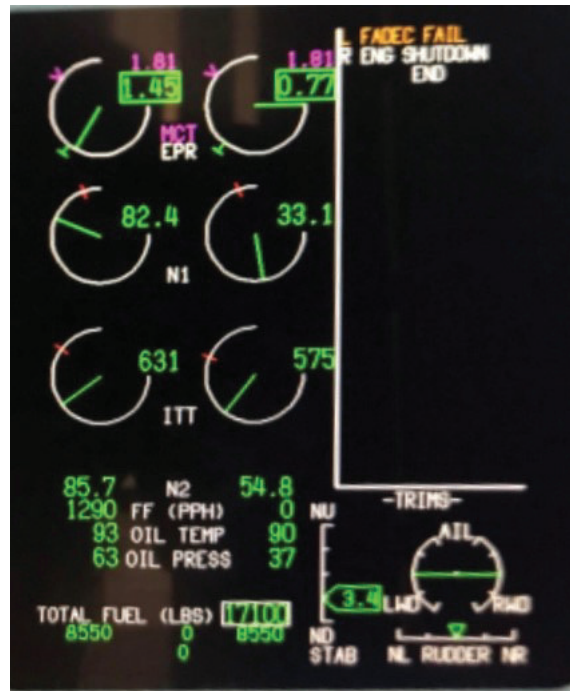
**Tab Z-17 (Simulated)**

When the right engine was shut down at 1251:16L, the crew alerting system would have posted a status crew alerting system message of "**R (Right) ENG SHUTDOWN**," displayed in white and below the other crew alerting system messages (Tabs J-180 and Z-17).

**EICAS Display #2:** A representative image of the crew alerting system messages just after the right engine shutdown.

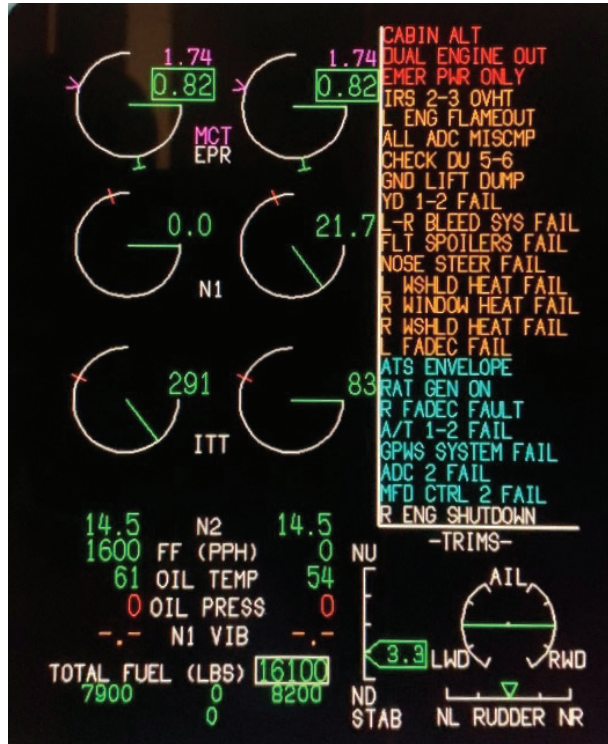
Tab Z-16 (Simulated)

Dual engine failure indications from the crew alerting system occurred later, estimated at 1252L (Tab J-180). The red **“DUAL ENGINE OUT”** warning crew alerting system message indicates that both engines have failed/been shutdown (Tab AA-3). This message is designed to display when both the left and right engines indicate either an amber **“ENG FLAMEOUT”** caution crew alerting system message or white **“ENG SHUTDOWN”** status crew alerting system message (Tab J-180). Thus, rather than displaying immediately when the right engine run switch was placed to off and the left engine had been shut down by the FADEC, the red **“DUAL ENGINE OUT”** warning crew alerting system message and an associated red Master Warning light on the glareshield did not appear until the **“L ENG FLAMEOUT”** was triggered as that engine’s internal RPM dropped below 35%, estimated some 30-45 seconds later (in accordance with system logic (Tab J-180 and Z-16)). Note that the flameout caution and dual engine warning would have preceded the red **“CABIN ALT”** (altitude) warning crew alerting system message, and several other systems messages (Tab Z-16 to Z-17).

**EICAS Display #3:** A representative image of cockpit indications following the amber “**L ENG FLAMEOUT**” caution, red “**DUAL ENGINE OUT**” warning, and red “**CABIN ALT**” warning crew alerting system messages with associated systems messages.

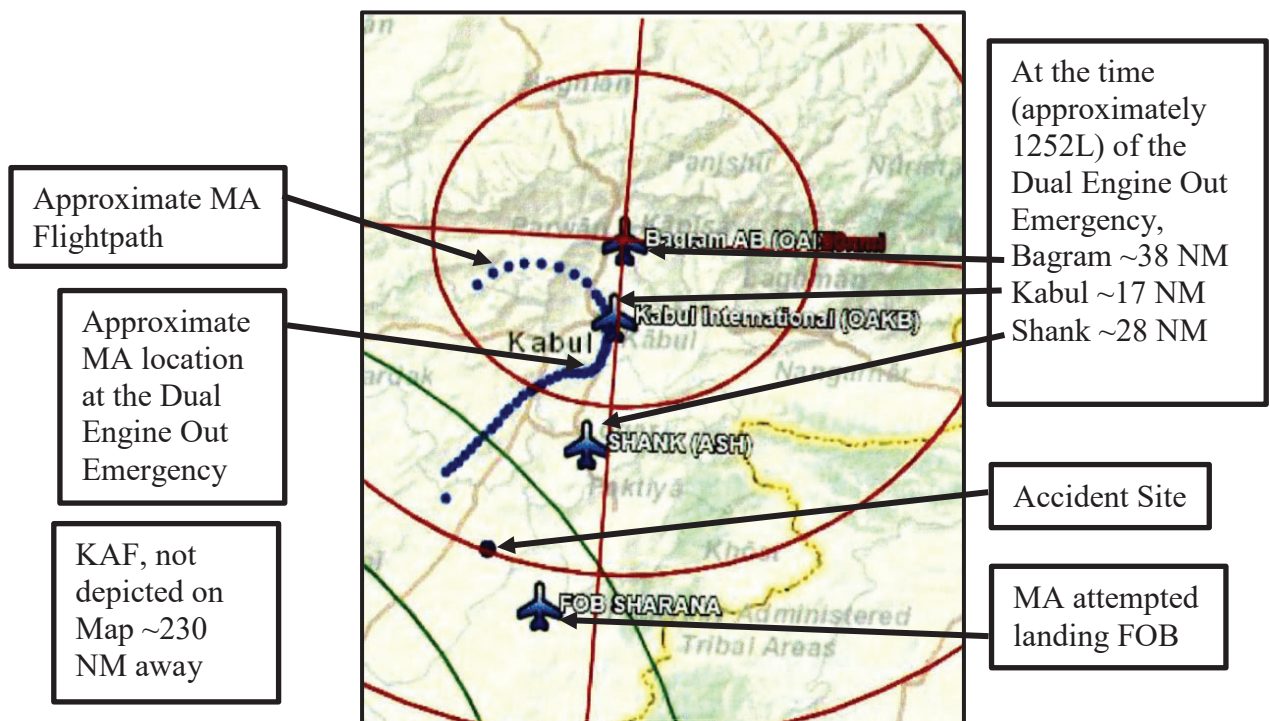
Tab Z-4

Even with the loss of both engines, backup E-11A systems would have allowed the MA to be controlled through an emergency landing. Additionally, both performance data and flight simulation profiles suggest that a divert to another airfield was still possible after the dual engine emergency (Tabs DD-6 to DD-7). However, the probability of a successful dual engine out landing cannot be determined, since it has never happened, and the MC would have had to accomplish a divert procedure not executed for at least several months prior to the mishap (Tab V-26.14). The MC would need to alter the flight plan, accomplish normal, emergency and divert checklists,

initiate communications, and manage their descent and routing to arrive at the divert airfield in a position to land without thrust to correct any miscalculations (Tab AA-37 to AA-42) .

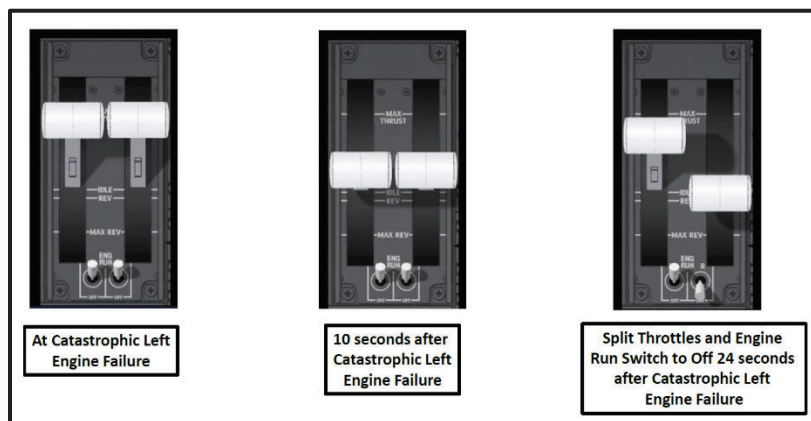
Tab Z-12 (Simulated)

Ten seconds after the catastrophic left engine failure, the MC retarded both throttles to just less than half way (14 degrees; total throttle range is from 0 – 40 degrees) for one second, then slightly advancing the left throttle separately (26 degrees) for one second, then retarding it to align with the right throttle (both at 16 degrees) for one second, and finally splitting the throttles to advance the left throttle (to 31 degrees) while retarding the right to idle (0 degrees). Nine seconds after moving the right throttle to idle, the MC placed the right engine run switch to off (moving the throttle to idle before switching the engine run switch to off is a FCOM checklist procedure when it is a crew initiated engine shutdown), effectively shutting down the right engine. See Figure **Tab Z-12**, which is a representative image of the throttles and engine run switch panel. Because of the minimal time spent in each throttle position, the above throttle movements could not be used reliably to assess engine response.

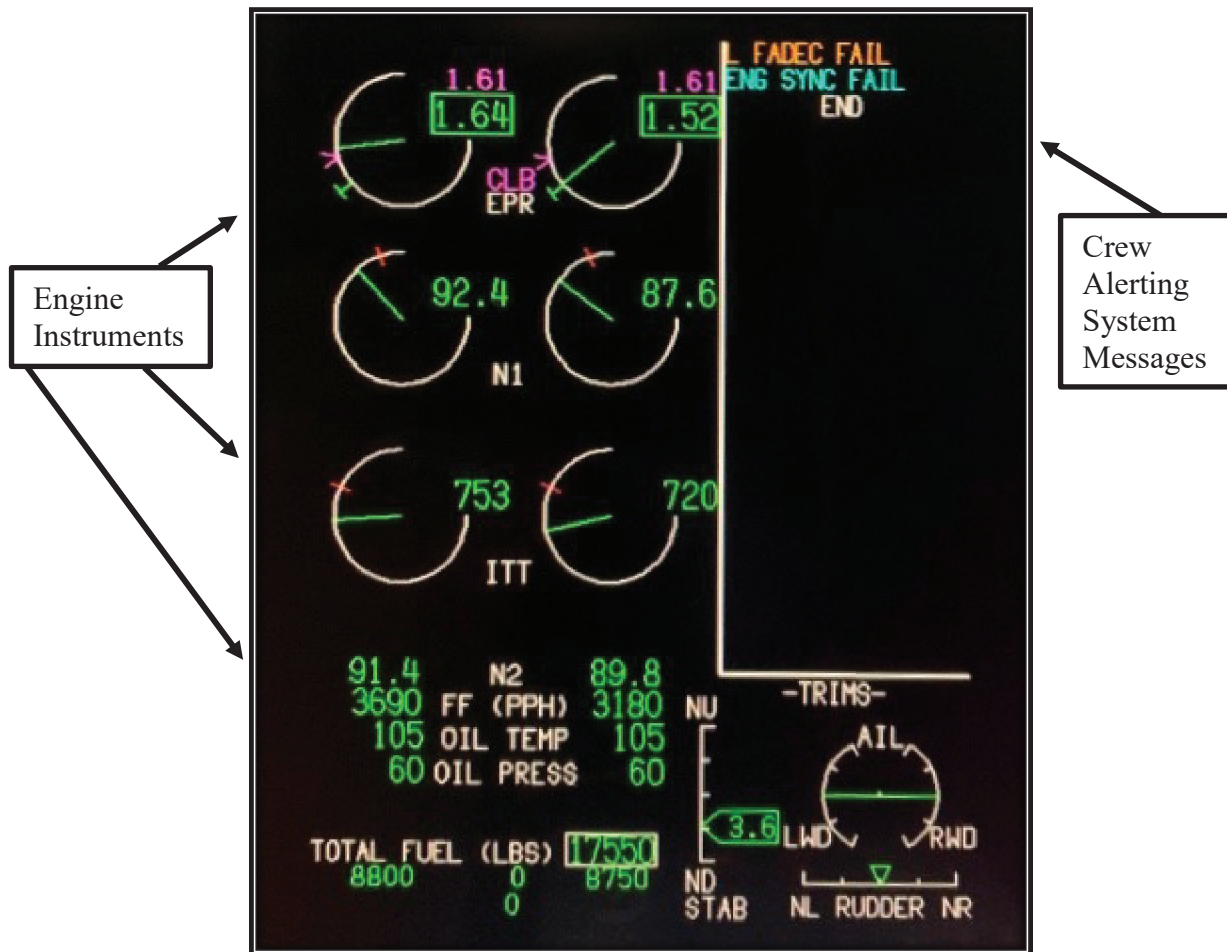
Tab Z-13 (Simulated)

The E-11A’s EICAS displayed an amber “**L FADEC FAIL**” caution crew alerting system message with an amber Master Caution light on the glareshield concurrent with the FADEC shutdown of the left engine (a consequence of the L FADEC FAIL message). Figure **Tab Z-13** depicts a representative image of the EICAS display and shows crew alerting system messages 1-2 seconds after the catastrophic left engine failure and the FADEC-directed engine shutdown. Importantly, the engine instruments do not reflect those of the MA and may differ.

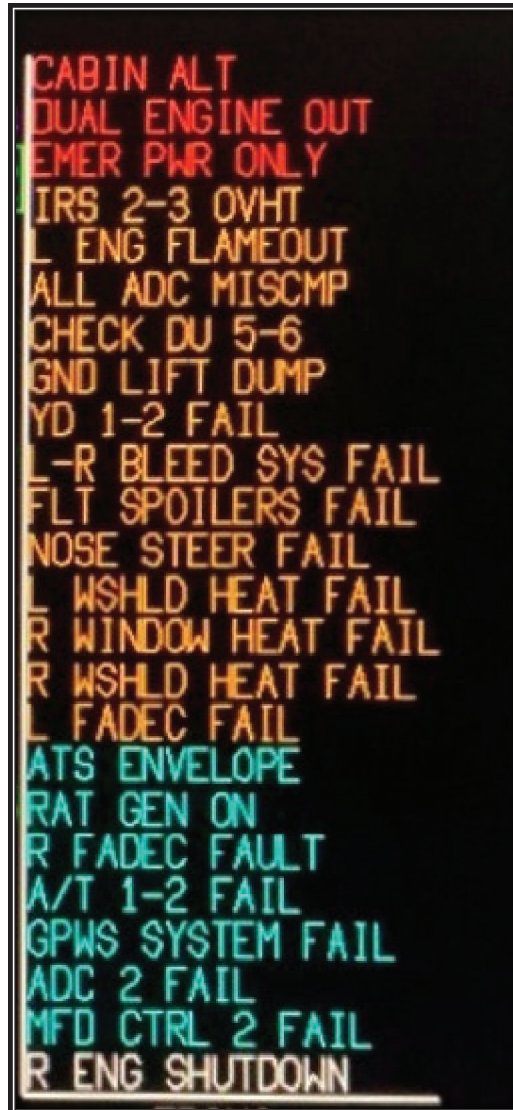
Tab Z-16 (Simulated)

In the first 24 seconds after the catastrophic left engine failure, the EICAS crew alerting system display did not necessarily suggest an engine failure. However, when the MC initiated shutdown of the right engine, it would have triggered an immediate white “**R ENG SHUTDOWN**” status crew alerting system message. Then, once the left engine RPM decreased below 35% (approximately 30 seconds after the right engine shutdown), an amber “**L ENG FLAMEOUT**” caution crew alerting system message would have been displayed followed by a red “**DUAL ENGINE OUT**” warning crew alerting system message, and a red Master Warning light (approximately 1252L). Of note, other EICAS crew alerting system messages would have been displayed, but are not important in this analysis of determining the affected engine. Figure **Tab Z-16** depicts a representative image of the crew alerting system part of the EICAS display and the crew alerting system messages showing the right engine shutdown, dual engine out, and left engine flameout messages indicating a dual engine out emergency.

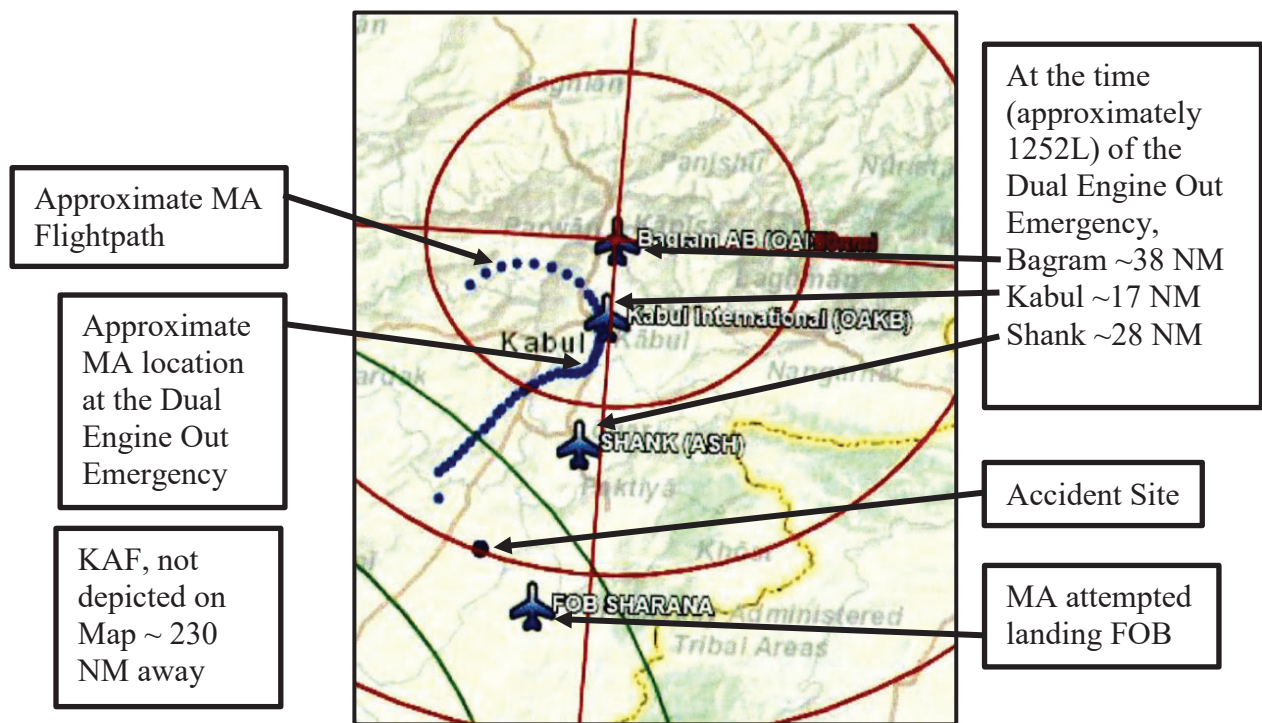
Tab Z-4

Even with the loss of both engines, backup E-11A systems allow the aircraft to be controlled through an emergency landing, and both performance data and flight simulation profiles suggest that a divert to another airfield was still possible even after the dual engine emergency. However, the exact probability of a successful dual engine out landing, since it has never happened, cannot be determined. In fact, the MC would have had to accomplish a procedure only considered hypothetically. During the mishap, the MC would need to alter the flight plan, accomplish checklists, initiate communications, and manage their descent and routing to arrive at the divert airfield in a position to land without the ability to correct any miscalculations.
